FINAL REPORT, PROJECT HERMES V-2 MISSILE PROGRAM

A Report of
Guided Missiles Department
Aeronautic and Ordnance Systems Divisions
Defense Products Group
Schenectady, New York

Author WHITE, L. D.	Subject Classification MISSILES, GUIDED	No. R52A0510 Date SEPTEMBER, 1952
------------------------	--	--

Abstract THIS IS THE FINAL REPORT ON V-2 OPERATIONS CONDUCTED AT THE WHITE SANDS PROVING GROUND AS PART OF PROJECT HERMES. PRIMARY ATTENTION IS GIVEN TO THE PERFORMANCE OF THE MISSILE AND THE COMPONENTS. OPERATIONAL AND TEST PROCEDURES AS USED AT WSPG ARE DISCUSSED. THE PROGRAM WAS CONCLUDED IN JUNE 1951 AFTER 67 ROCKETS USING V-2 COMPONENTS HAD BEEN CONSTRUCTED, TESTED, AND LAUNCHED.
--

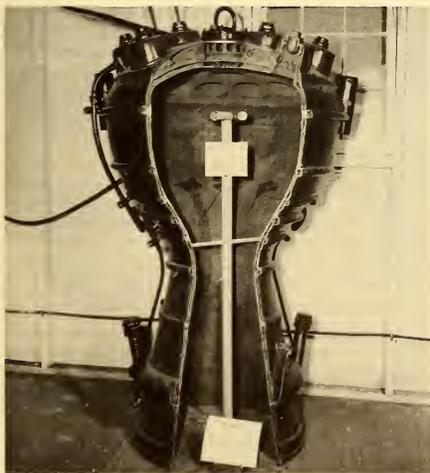
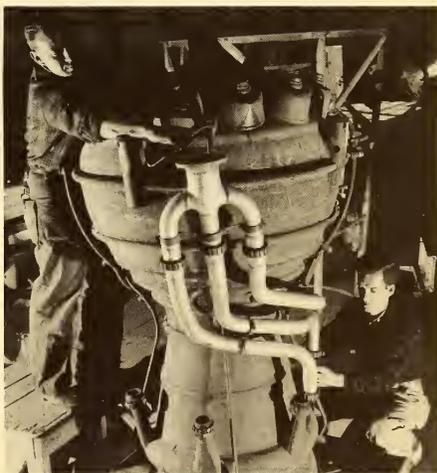
Fig. 29 Cutaway of V-2 Burner (left) and Burner-piping Installation (right)

Many of the burners at WSPG had mounting brackets knocked out of line, cooling lines mashed and expansion joint fittings and cooling line fittings (Fig. 29) knocked off. Almost every burner used had some defect requiring a welding-repair. One burner used at WSPG had a flattened main valve seating ring. This was probably caused by mishandling some time after manufacture. In addition to these defects, some burners had to have loops welded into the cooling lines. Also, some sheet metal skirt covers were rusted through, and had to be repaired or replaced.

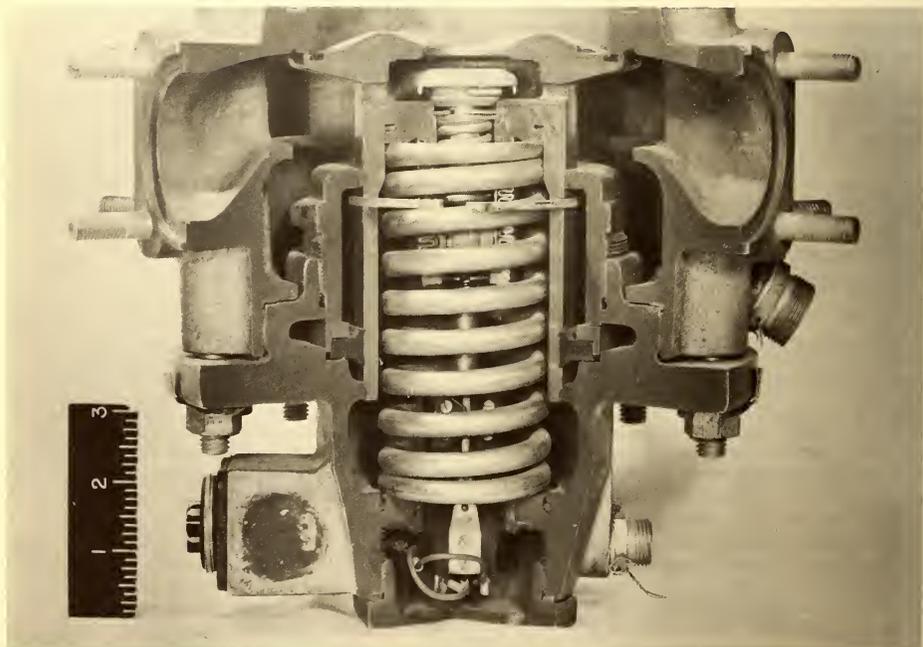
Fig. 34 Cutaway View, Main Oxygen Valve

In the latter part of 1948, it was found that the double lip seal was loosening when the valve was cooled with liquid oxygen. Tests at Fort Bliss and WSPG showed that control air leakage increased greatly; lox vapors from the switch battery were observed. It was found that tightening of the seal nut when the valve was cold would decrease the leakage. However, if the seal nut was tightened too much, a rough stroke would sometimes result. Additional cold tests at Fort Bliss indicated that it was the temperature difference between the seal and the cylinder that was causing the leakage. Cold tests were run with a calrod unit wrapped around the bottom of the valve; this reduced the leakage considerably. The calrod power was supplied by a variac which was adjusted to insure that the calrod would not become uncomfortably hot to the touch. Immediately after the double lip seal trouble was discovered, missiles were supplied with a 25-ton valve on the bottom of the main valve to aid in venting the control chamber. The vent lines on the 25-ton valve and on the switch battery were run to the side of the missile. Also, the calrod was utilized and control air leakage was monitored until access ports were closed to make sure the seal was not loosening to a dangerous degree.
